**RE: Self- Implementation PCB Remediation Plan
Demolition of Remaining Portion of
Former Salem State University Library
360 Lafayette Street, Salem, Massachusetts**

**SELF-IMPLEMENTATION PCB
REMEDATION PLAN
ADDENDUM**

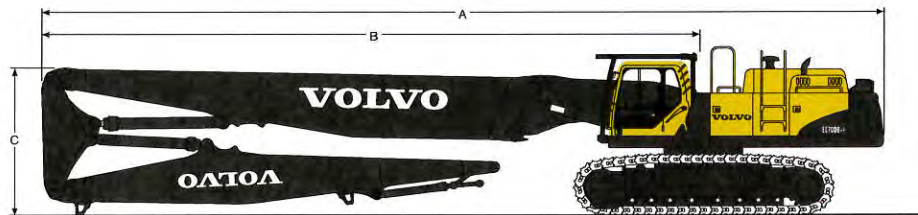
Dimensions of demolition machine including 3-piece demolition attachment

Description		EC360CHR		EC460CHR		EC700BHR	
A. Overall length	mm	14,350		19,280		19,130	
	ft-in	47' 1"		63' 2'		62' 9"	
B. Swing center to front of equipment	mm	10,960		15,400		15,040	
	ft-in	35' 11"		50' 5'		49' 4"	
C. Maximum height of boom in transport position	mm	3,110		3,070		3,350	
	ft-in	10' 2"		10' 1'		11' 0"

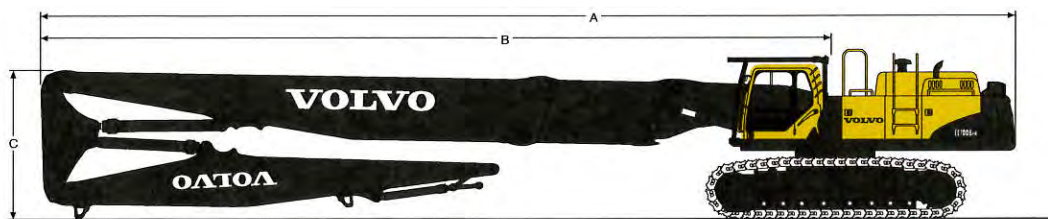
Dimensions of demolition machine including 3-piece demolition attachment and boom extension

Description		EC700BHR	
A. Overall length	mm	22,130	72' 7"
	ft-in	72' 7"	72' 7"
B. Swing center to front of equipment	mm	18,040	59' 2"
	ft-in	59' 2"	59' 2"
C. Maximum height of boom in transport position	mm	3,340	10' 11"
	ft-in	10' 11"	10' 11"
